Manhole Inspection Summary

Manhole # S45GG_065MH

Insp Date: **3/13/08 11:31 AM**

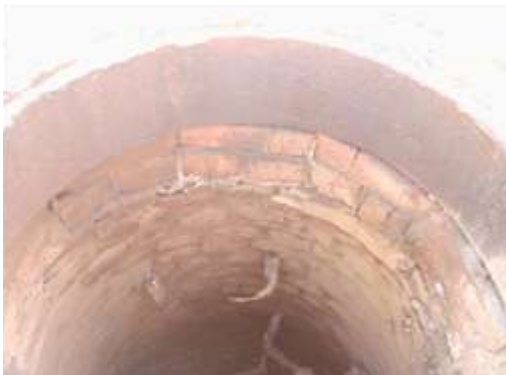
Defect 1

Condition: ☐ Sound ☐ Cracked ☐ Root Intrusion ☒ **Loose Brick** ☐ Deteriorated

loose bricks

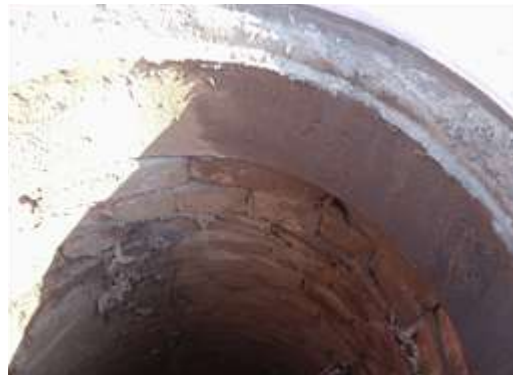
Defect 3

☒ **Leaks**

frame leaks

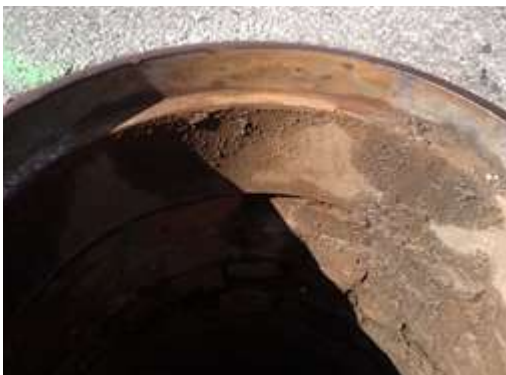
Defect 2

Offset: **1** (in.)

offset

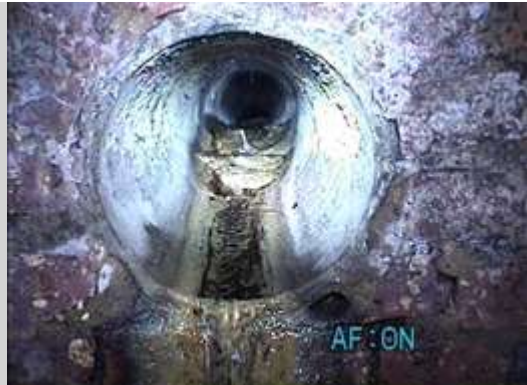
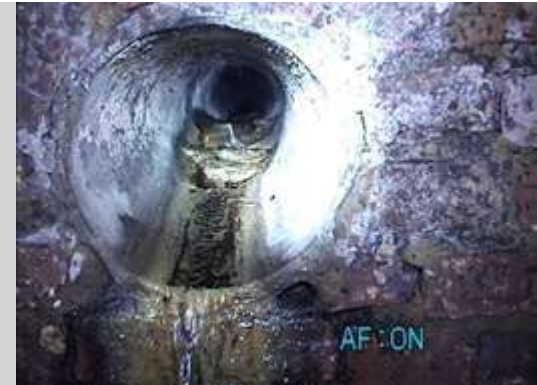
3 O'Clock Inflow

Pipe Height: **8.4** (in.) Rod and Bar (Angled)
Pipe Material: **Clay** ☐ Pipe Lined
Invert Depth: **9.10** (ft.) Flow Characteristics: **Fast**
Deposits: ☐ None ☐ Mud ☐ Sludge ☒ **Debris** ☐ Grease
Silt Depth: **2** (in.) Deposits Extent: **Light**
Infiltration: **None** Pipe Seal Cond: **Sound**

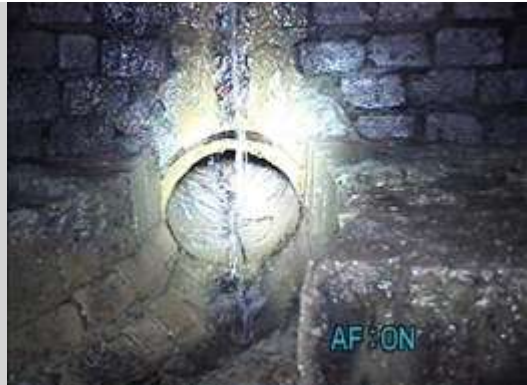
Drop In @ 3 O'Clock

Drop: Inside	Rod and Bar
Angled: Yes	Reading: 10.50 (ft.)
	Inv Depth: 11.50 (ft.)

Drop Condition: **Open**
